MEVOTECH INSIDER

Correct Diagnostic Procedure for 2003-2019 Sprinter Van Front Lower Ball Joints

Brand	Suprem	e/TTX	Product	Ball Joints	Date	February 2021
Part Number(s)		MK7455/MS25	516/TXK74	55/TXMS25516

Topic number	LI33.00-N-066643
Version	2
Function group	33.00 General
Date	10-18-2017
Validity	Model 901.###, 902.###, 903.###, 904.###, 905.###, 906.###
Reason for change	Addition of 906.###
Reason for block

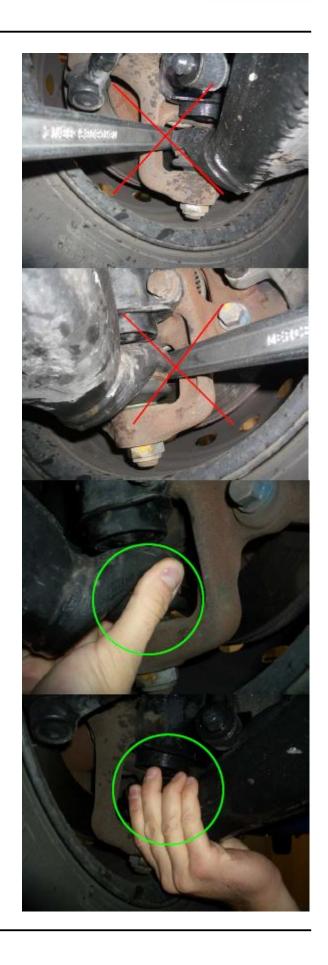
01.jpg:

Attachments	
File	Description
01.jpg	Supporting ball joint check

- Raise the vehicle at the front axle at the center of the crossmember at the level of the leaf spring using a floor jack until the wheels are no longer in contact with the ground.
- When raising the vehicle, monitor whether there is lateral misalignment (radial play) in the supporting joint.
- Misalignment of more than 3 mm is rated as a serious defect by the technical inspection associations.

- Visual inspection for correct seating and possible damage.
- Squeeze the boot together (using your fingers, not tools) to check the concealed parts and to establish whether moisture has penetrated the joint.
- Damage to the dust boot must be rated as a serious defect (if such damage exists, the supporting joint can be expected to fail soon).
