Turbo linkage

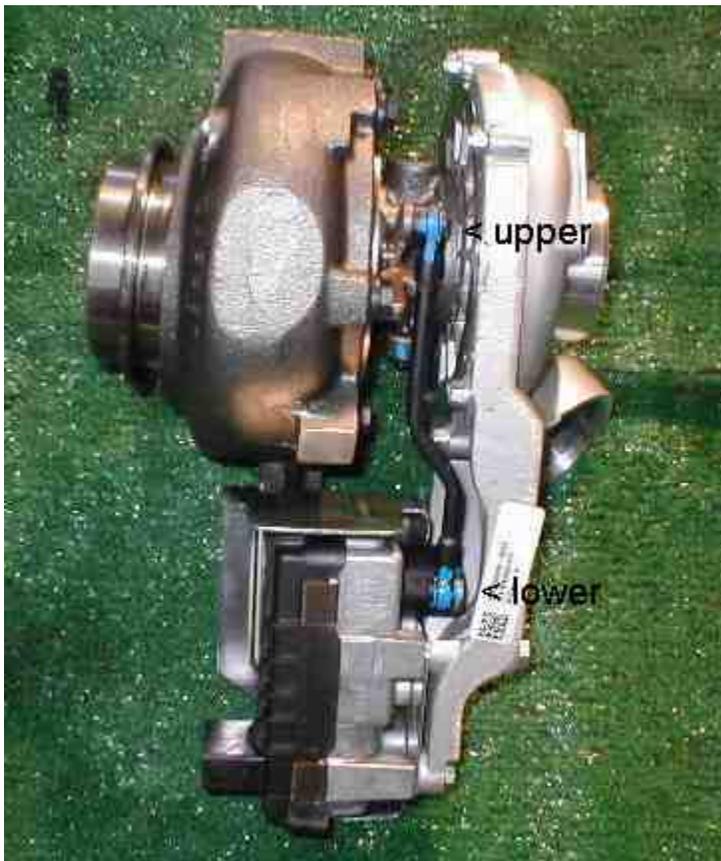
The bottom swivel on the **linkage** was frozen from corrosion. Took apart, cleaned, lubed with a touch of moly, back together and all is working. Got my lovely **turbo** whine back!
